# Report on the Loss of the Mars Polar Lander and Deep Space 2 Missions

JPL Special Review Board

22 March 2000

JPL D-18709

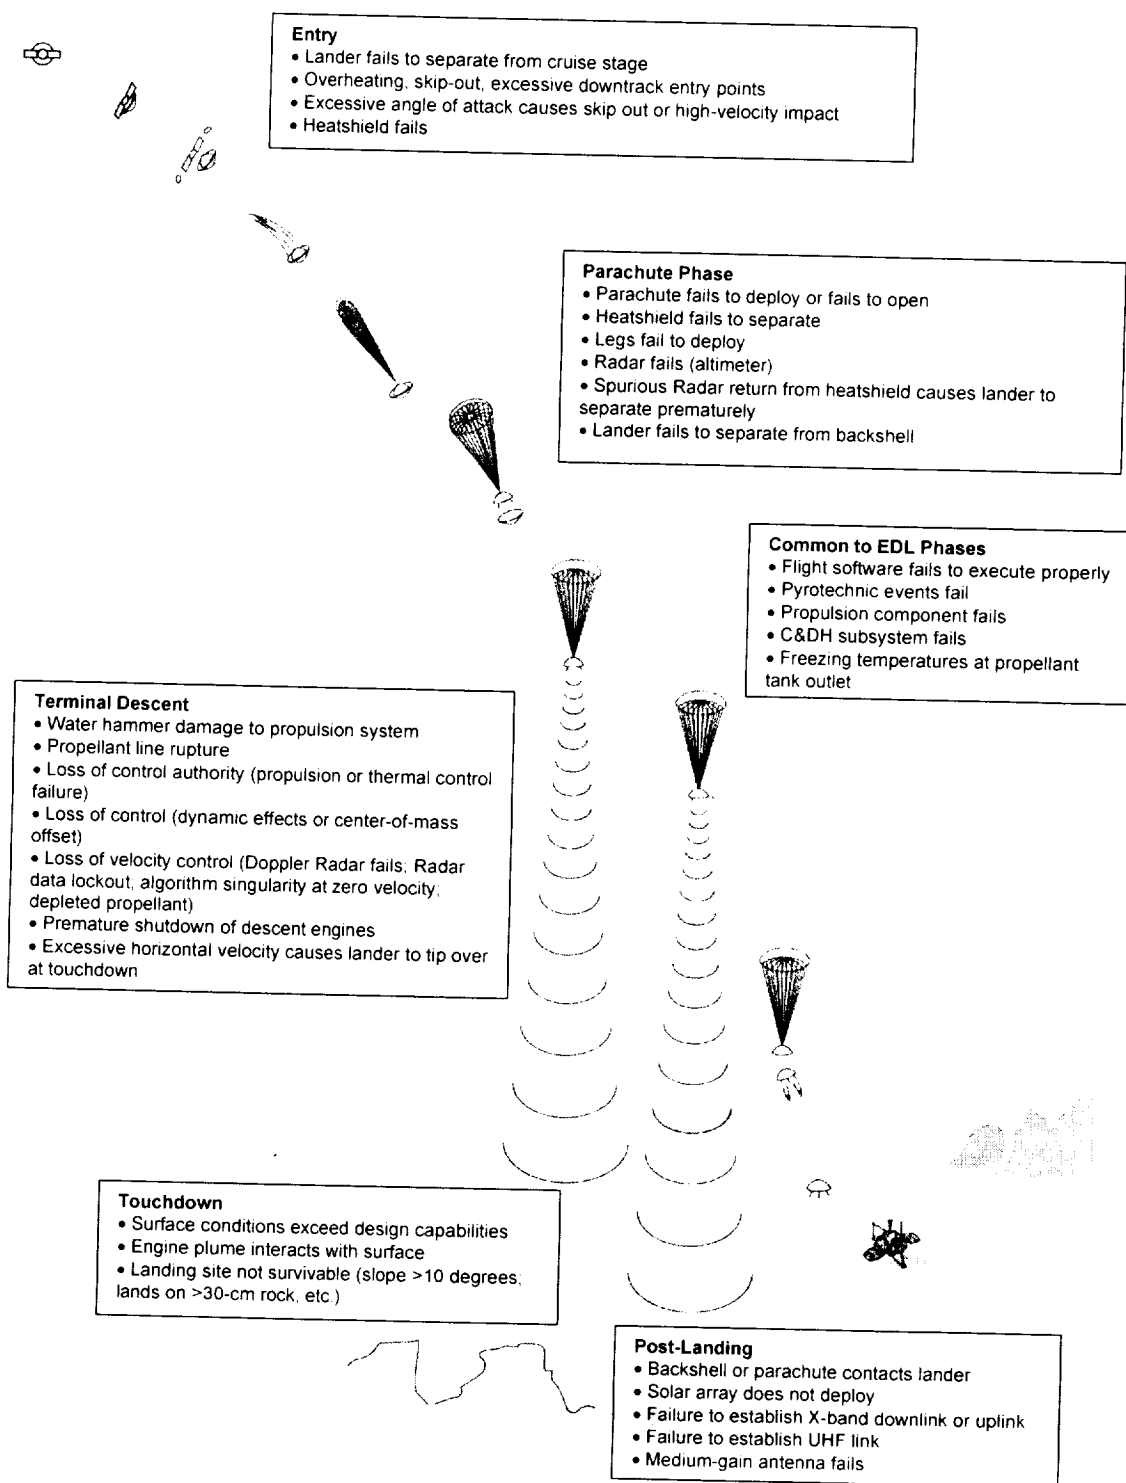
**Figure 6-1. MPL Entry, Descent, and Landing (EDL) Sequence with Potential Failure Modes**

Figure 6-1 depicts the MPL EDL sequence and shows potential failure modes.

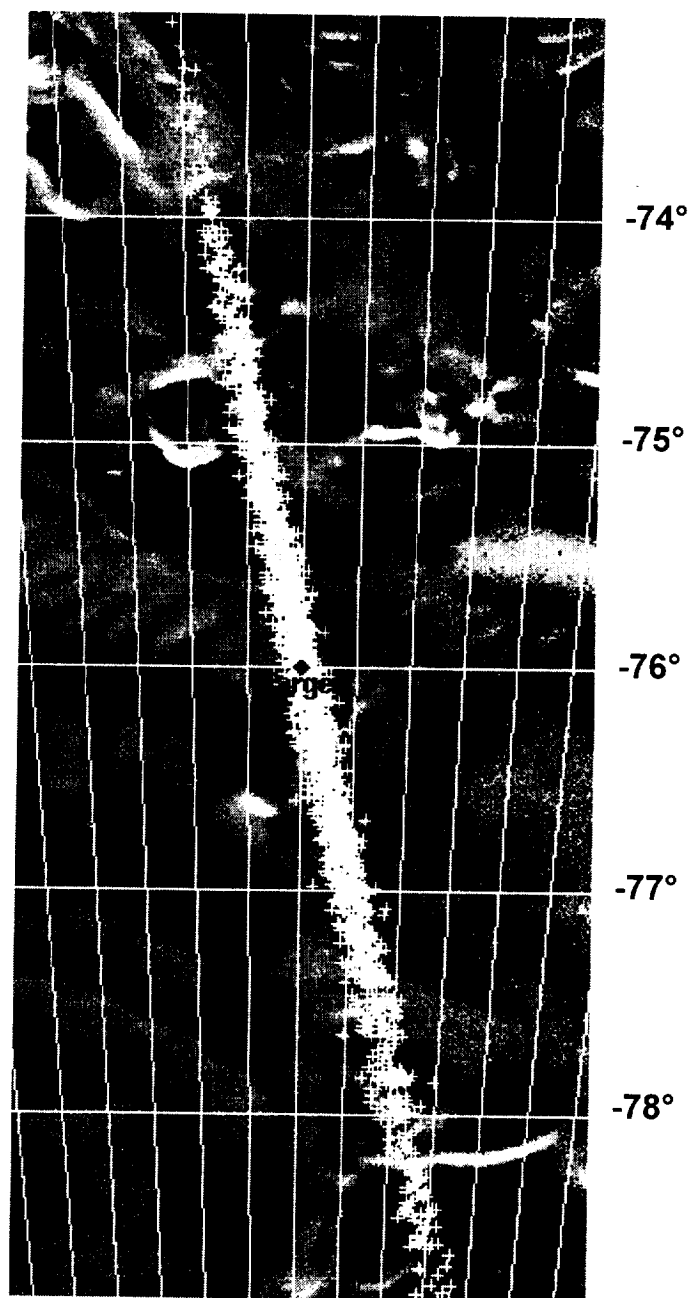
**Figure 7-2. TCM-4 Planning Ellipse — LaRC 3DOF Scatter, 11/23/99**

Analyses performed after EDL revealed that the effects of maneuver-execution errors were larger than expected. The TCM-4 planning ellipse was based on a maneuver magnitude of 0.35 meter per second, the best estimate available at that time. The final TCM-4 maneuver magnitude was 0.6 meter per second. This maneuver magnitude resulted in considerably larger execution errors than had been previously assumed. For very short burns, execution errors are small because little time is available for pointing errors to develop. For longer burns, errors are also small because the control system will steer back to the desired attitude. The executed burn magnitude fell in between these extremes and, therefore, was subject to a larger set of expected errors. This increased the size of the 3-sigma B-plane error to as high as 20.5 kilometers  $\times$  13.8 kilometers, using worst-case requirement estimates of maneuver-execution errors. (Typical or "expected" maneuver-execution errors led to substantially smaller B-plane errors (18.3 kilometers  $\times$  6.2 kilometers). This widening effect is illustrated in Figure 7-3, which shows both the narrow TCM-4 planning ellipse, based on the assumed maneuver magnitudes and associated error statistics, and the wider ellipse, based on the actual maneuver magnitude and associated error statistics. This graphic represents the difference between the delivery accuracy that the project assumed was achievable at the time of TCM-4 versus what is now believed to be the best estimate, after the fact. Also shown is the center of the final navigation solution based on tracking data after TCM-5 through the loss of signal.

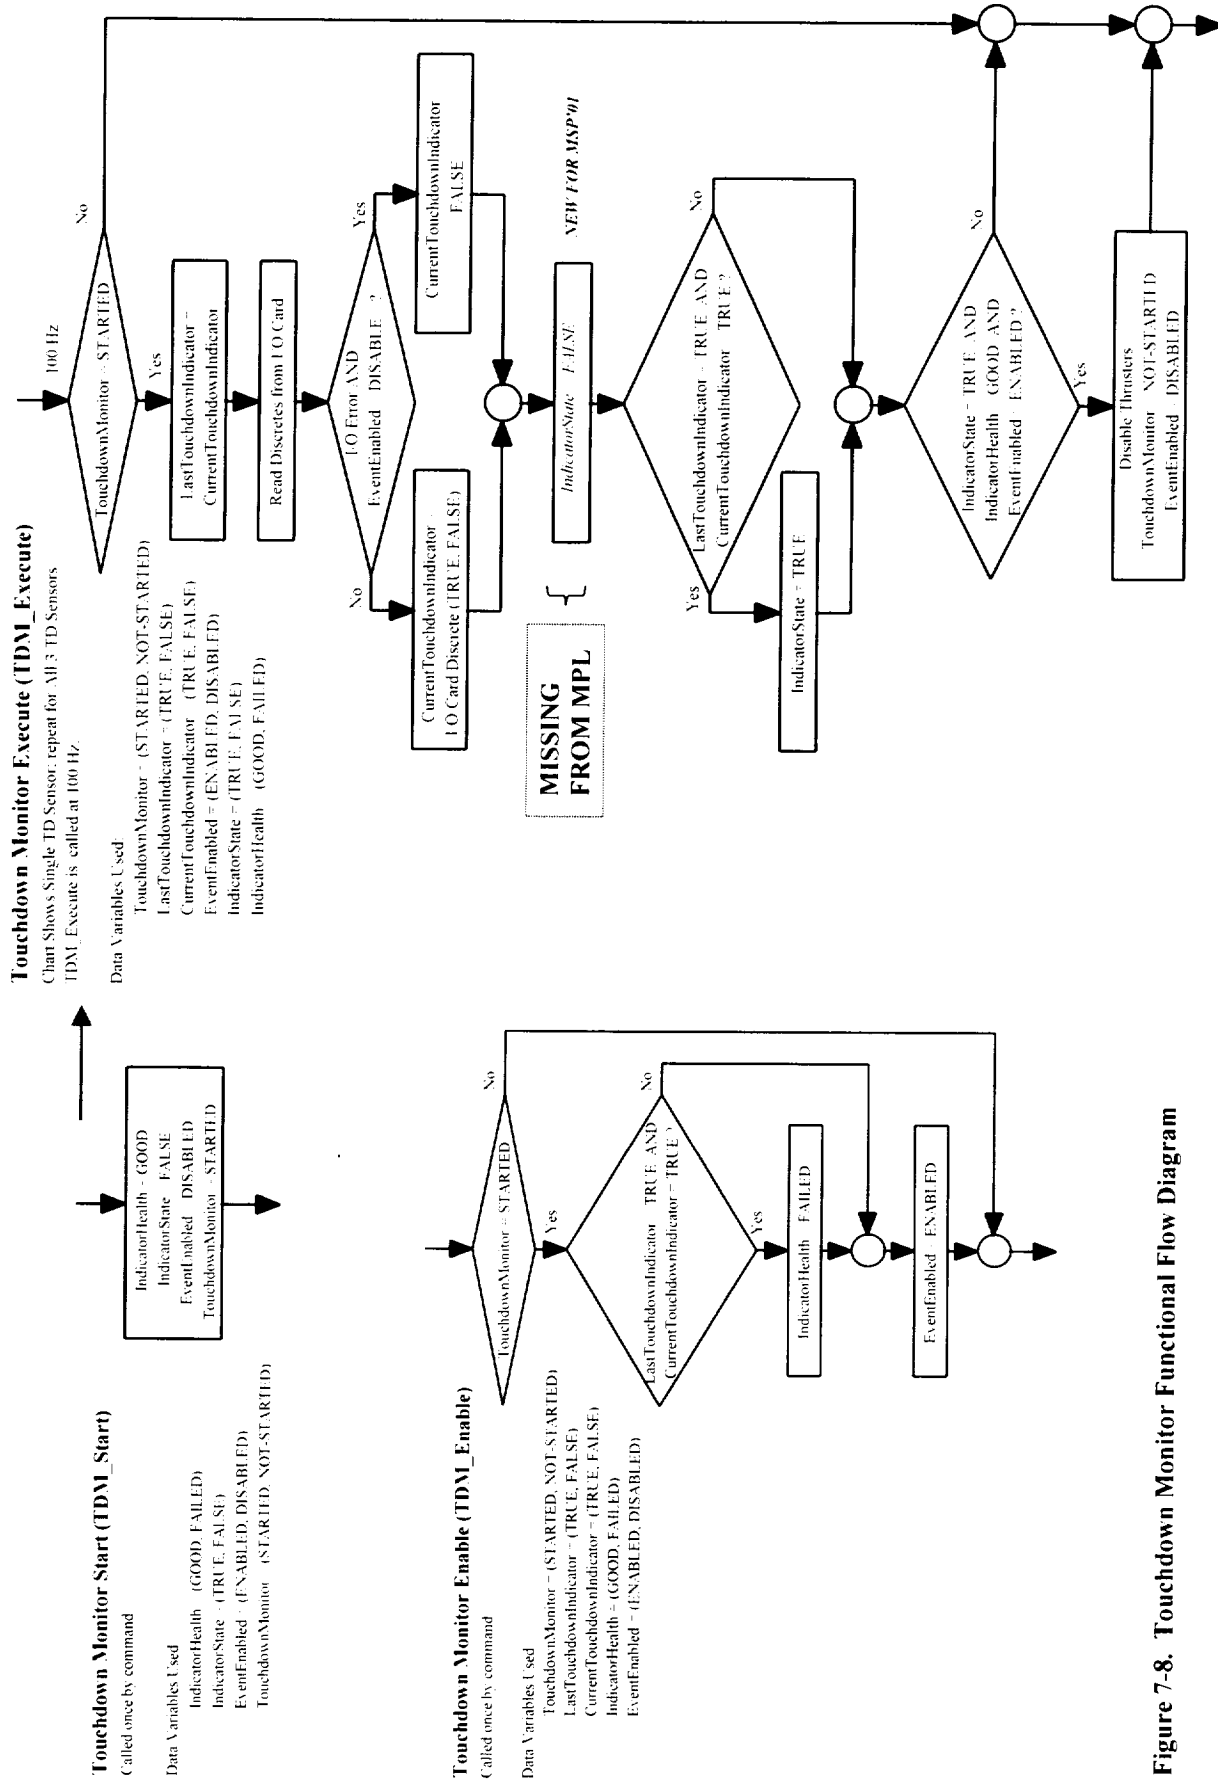
The design logic to implement the requirements is shown in the flow diagram in Figure 7-8.

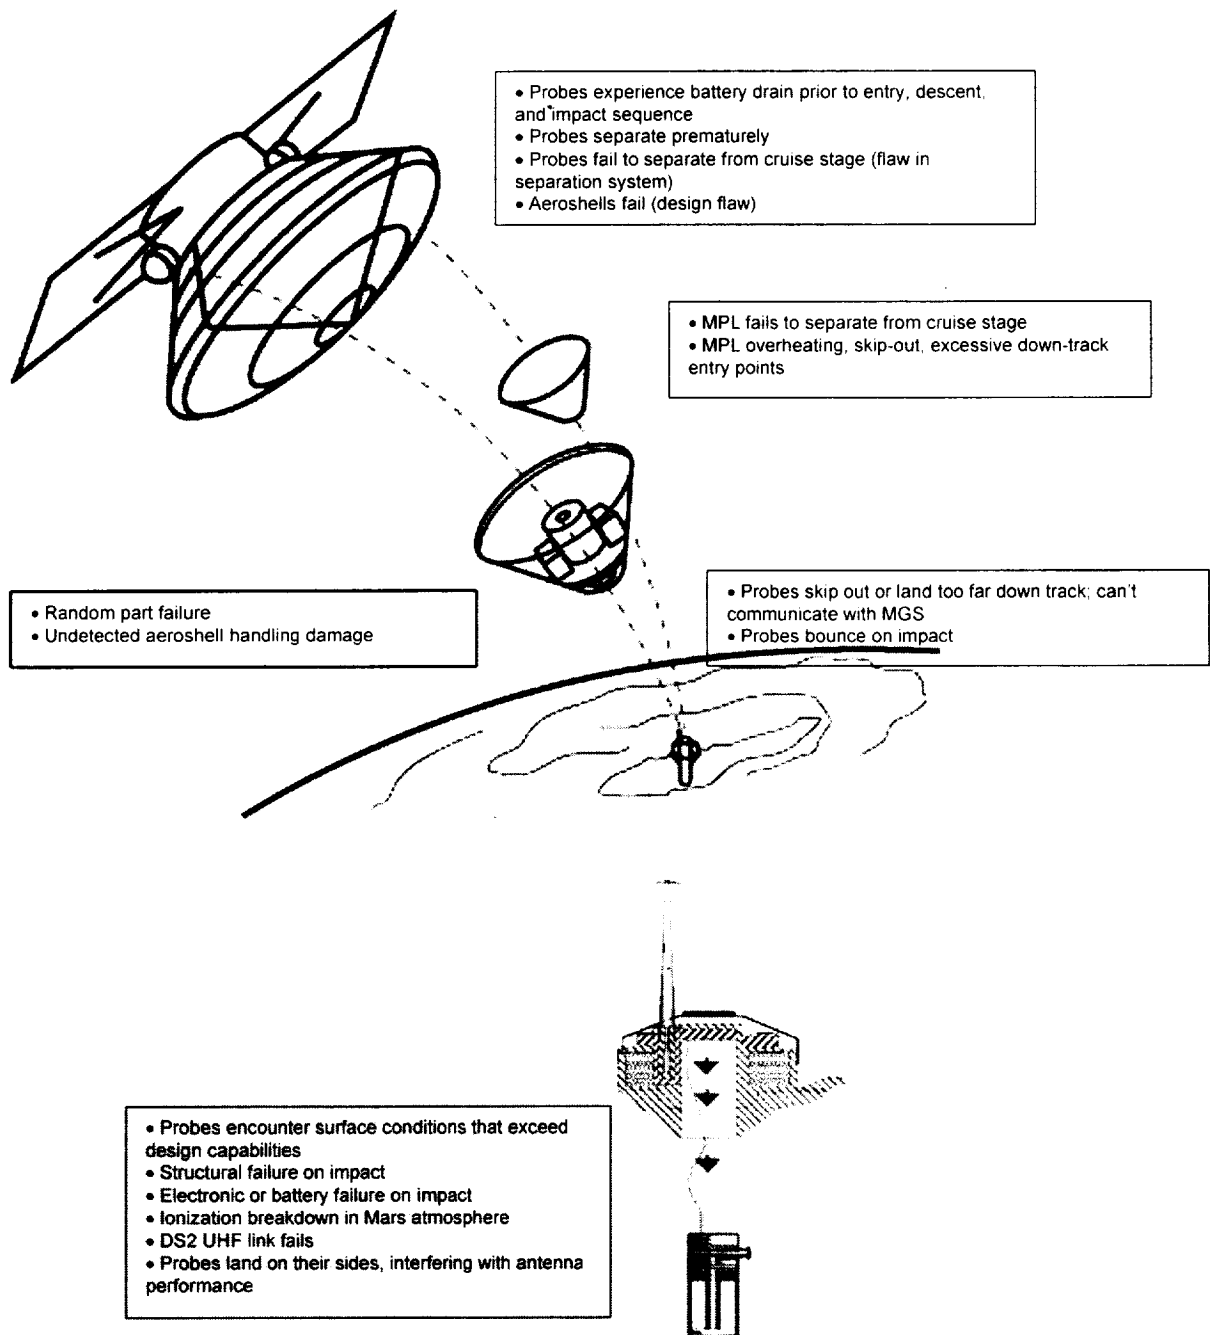
**Figure 8-1. DS2 Entry, Descent, and Impact Sequence with Potential Failure Modes**

The four DS2 potential failure modes identified by the Board as plausible are highlighted as *FLAG 1*, *FLAG 2*, *FLAG 3*, and *FLAG 4*.

Figure 8-1 illustrates the DS2 entry, descent, and impact (EDI) sequence and shows potential failure modes.
